**ARMORFORM® Articulating Block Mat
Erosion Control System
Salmon Creek Bridge; Oakridge, Oregon**

Construction Report

**OREGON EXPERIMENTAL
FEATURE #OR89-05**

**OREGON STATE HIGHWAY DIVISION
Materials and Research Section
Salem, Oregon 97310**

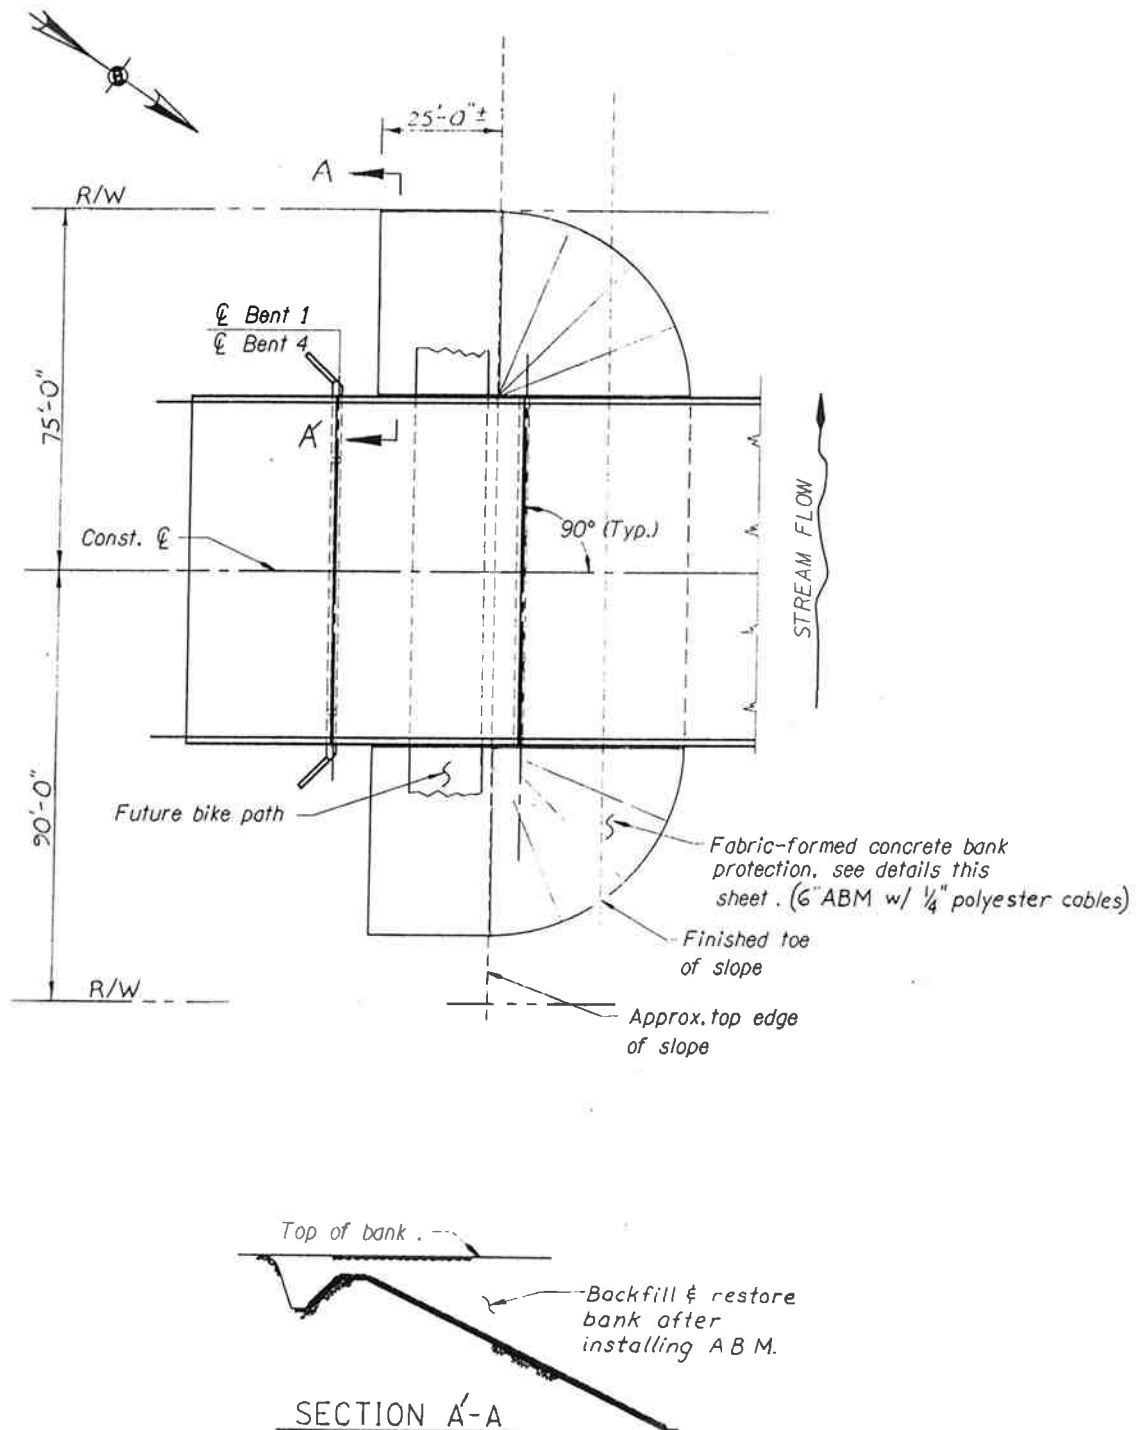
Figure 1
ODOT Design

In addition to the degradation problem, there was also a concern that erosion was progressing downstream toward the bridge along the west bank of the stream. Ordinary riprap would not have been sufficient to stop this flanking (or "sidemining") of the protection. The ABM, it was reasoned, could be wrapped around the abutment and buried in the stream bank to control the flanking problem. This concept was applied in the final ODOT design to all four corners of the bridge. This was illustrated in the plans as shown in Figure 1.

The concept of the original ODOT design (Figure 1) was modified somewhat as shown in Figure 2 when the shop drawings were made by Nicolon Corporation, for the subcontractor, Pacific Erosion. These drawings and the actual construction did not fully incorporate the concept of burying the ABM to full depth on two sides of the pier as shown in Section A'-A of Figure 1. Instead, the cross-section in the same area looks approximately as shown in Section B'-B of Figure 2. This modification took place because the fabric forms cannot be readily shaped as the ODOT design indicated. It is anticipated that this modification will make the system somewhat less effective than the original design in Figure 1 for controlling the tendency for erosion to progress by flanking around the end of the ABM. If erosion does progress, however, it will be a good test of the effectiveness of the ABM after it is undermined and begins to articulate.

- In the future, designers should communicate with a manufacturer's representative when planning a curved design. This will assure that the ABM, as constructed, functions as the designer intended. In this case, the intent of the designer was that the ABM should extend around two sides of the pier at full depth. This was to protect against the laterally progressing erosion of the westerly stream bank. In the final product, this intent was not fully realized. Close communication with the manufacturer's representative could assure that the functional intent, if not the precise form of the design, is realized in future projects.

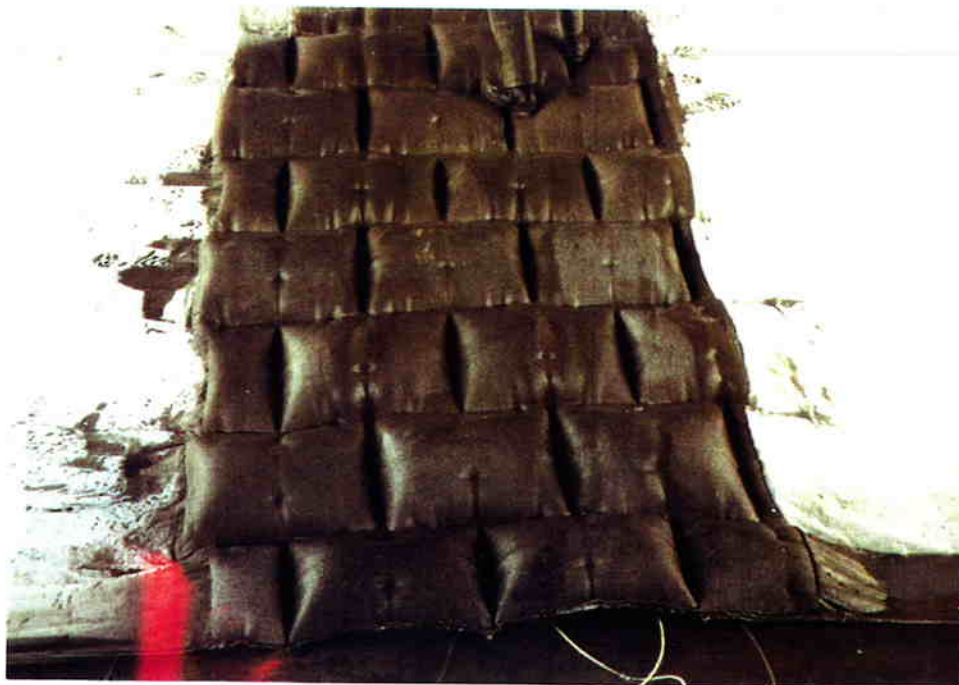
PHOTO 1
ABM Appearance After Filling

An Articulating Block Mat (see Photos 1 and 2) is one particular type of fabric formed concrete. Fabric forms for concrete come in many different designs, but all have the same general concept in common. A strong synthetic fabric is sewn into a series of bags that are connected internally by grout ducts. These bags are then filled with a cement rich concrete grout. When set, the concrete then forms a solid mat, often made of a series of connected blocks. The mat does not usually depend on the fabric itself for strength. The particular design called "articulating block mat" (ABM) has two features that enable these blocks to articulate (or bend) within the mat while the mat remains structurally sound. First, the horizontal seams are continuous, allowing the blocks to bend downward by hinging along this seam line. Second, the individual blocks are

- As with all forms of bank stabilization, it is essential that drainage be allowed. In this installation, it appears that excess grout is plugging the seams between the blocks in the ABM. These seams should be cut at five-foot intervals to assure that hydrostatic pressure does not build up if a sudden drawdown should occur after a flood.

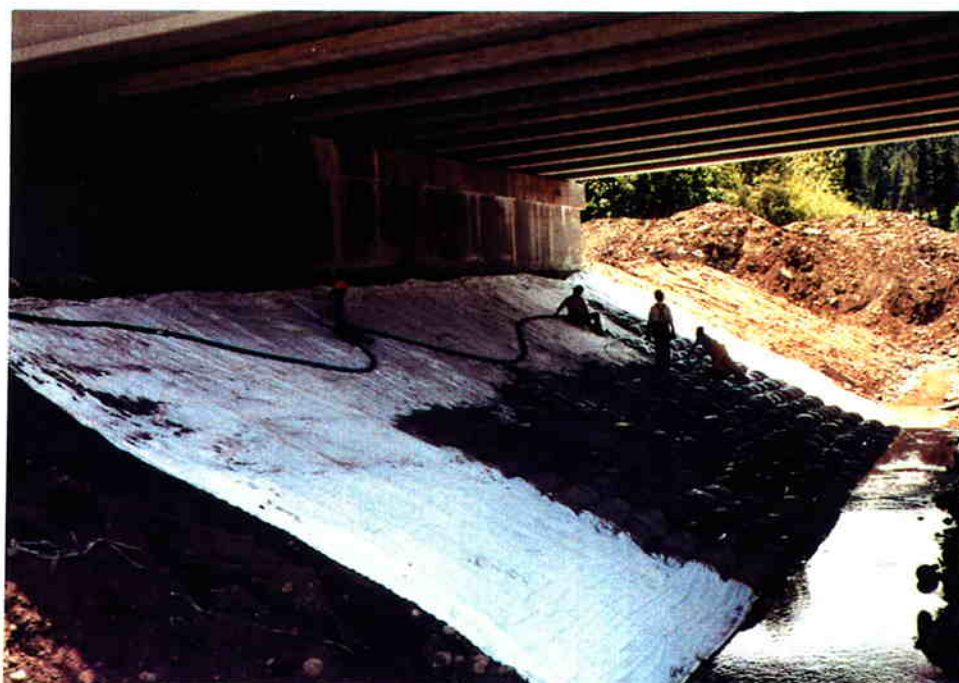
PHOTO 2
Easterly Stream Bank During Construction

Problem: It was difficult to maintain straight lines along the horizontal seams when pumping grout. The easterly* slope (see Photo 2) was the worst problem because of lack of experience. The first attempt was to tie the upper edge of the fabric directly to the anchors on the bent while the grouting process proceeded upward from the bottom.

Solution: After the first experience with the easterly slope, the fabric was kept straight on the westerly slope by tying it to a series of #6 reinforcing bars.
